**DEPARTMENT OF TRANSPORTATION**

Contract #: 04-0120F4Cty: SF/ALA Rte: 80 PM: 13.2/13.9File #: 1.28**WELDING INSPECTION REPORT****Resident Engineer:** Casey, William**Address:** 333 Burma Road**City:** Oakland, CA 94607**Report No:** WIR-027643**Date Inspected:** 23-May-2012**Project Name:** SAS Superstructure**OSM Arrival Time:** 700**Prime Contractor:** American Bridge/Fluor Enterprises, a JV**OSM Departure Time:** 1730**Contractor:** American Bridge/Fluor Enterprises, a JV**Location:** Job Site**CWI Name:** As noted below.**CWI Present:** Yes No**Inspected CWI report:** Yes No N/A**Rod Oven in Use:** Yes No N/A**Electrode to specification:** Yes No N/A**Weld Procedures Followed:** Yes No N/A**Qualified Welders:** Yes No N/A**Verified Joint Fit-up:** Yes No N/A**Approved Drawings:** Yes No N/A**Approved WPS:** Yes No N/A**Delayed / Cancelled:** Yes No N/A**Bridge No:** 34-0006**Component:** Tower Component**Summary of Items Observed:**

**Tower****In Process Visual Inspection**

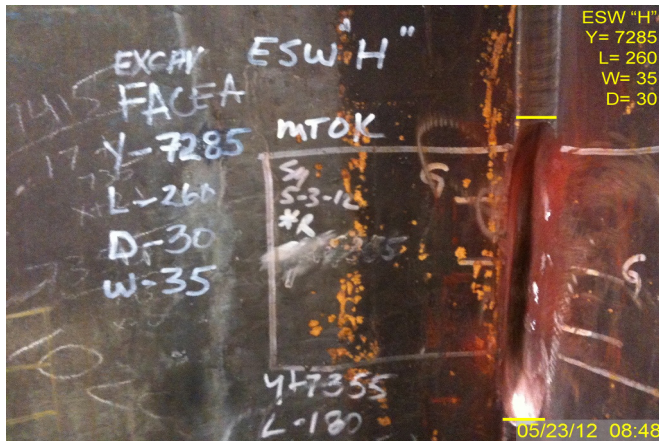
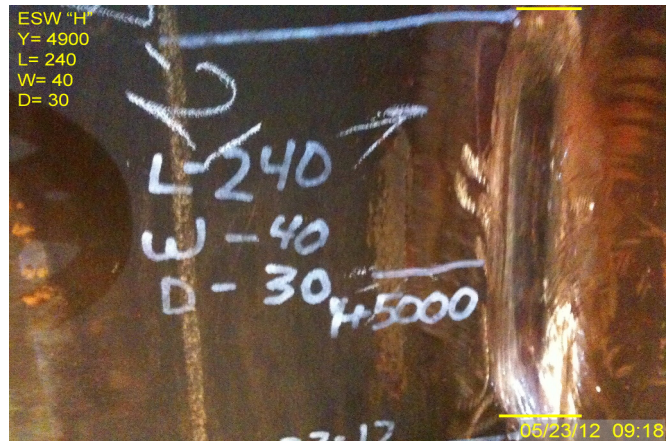
This QA Inspector performed Magnetic Particle Testing (MT) of weld repair excavations on two locations on tower ESW "H". This QA observed no rejectable indications at the time of testing. This QA Inspector generated a TL-6028 MT report on this date. The completed work observed at these locations appeared to be in compliance with the contract specifications.

Weld "H" – Y=7285mm, L=260mm, W=35mm, D=30mm

Weld "H" – Y=4900mm, L=240mm, W=40mm, D=30mm
